TO: Chief Smith
FROM: TST Tuckman
DATE: 05/17/2019
SUBJECT: Follow-up Evaluation Report – Washington St / Rte. 21

WASHINGTON STREET / ROUTE 21

RED LIGHT PHOTO ENFORCEMENT
1 YEAR FOLLOW-UP REPORT

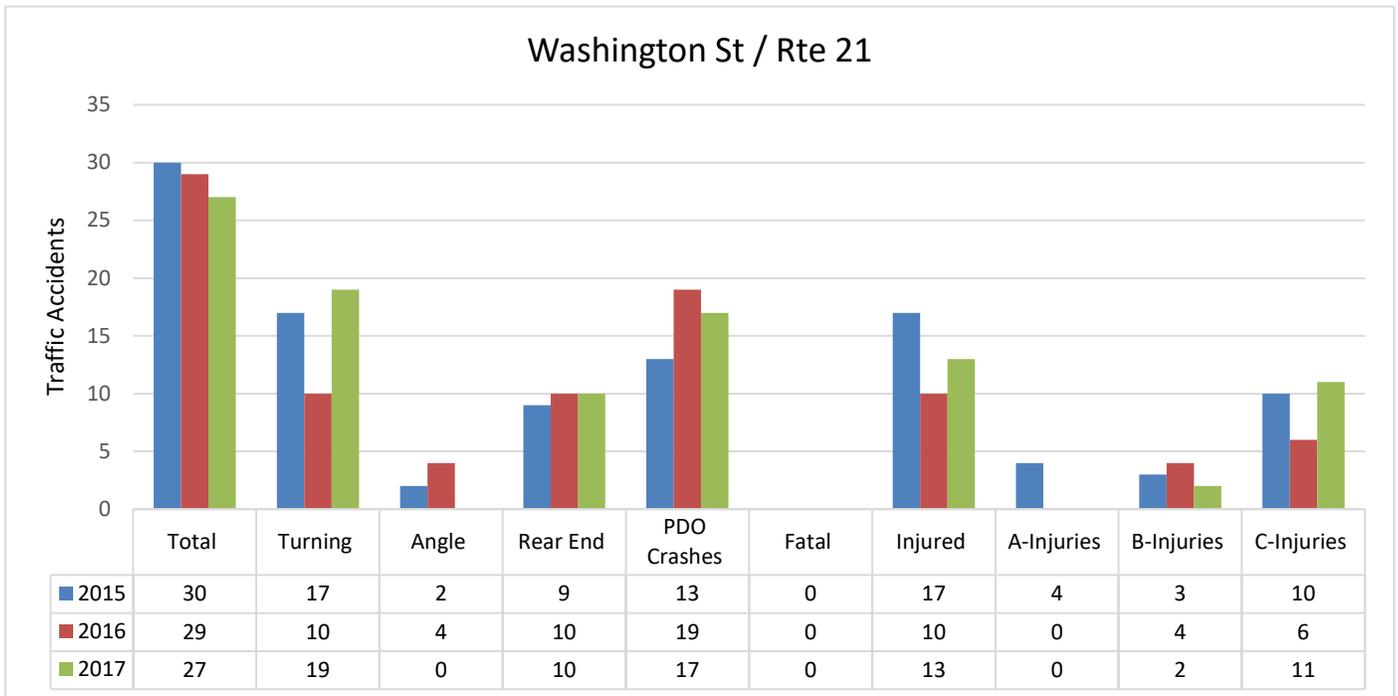
Exhibit #1

The crash data specific to the RLR location(s) for the 3-year period (Exhibit #1) prior to and for the period post (Exhibit #2) RLR installation. The crash data shall include yearly collision diagrams of the intersection(s).

**The above chart data is by calendar year running January through December

The 3 year traffic accident data (Exhibit #1) shows the total accidents for this period was consistent with the post RLR camera system installation. The post camera system accident data (Exhibit #2) does not give enough long-term data to draw a conclusion on the effectiveness of the RLR camera system. While total traffic accidents remained consistent, there was one (1) fatal accident at this location as well as an increase in Type-A injuries. These two increases are related to two (2) serious turn-related accidents in 2018. While Type-A accidents did increase, overall injury accidents (7) post RLR did decrease from the 3 year average (12) by approximately 41%.

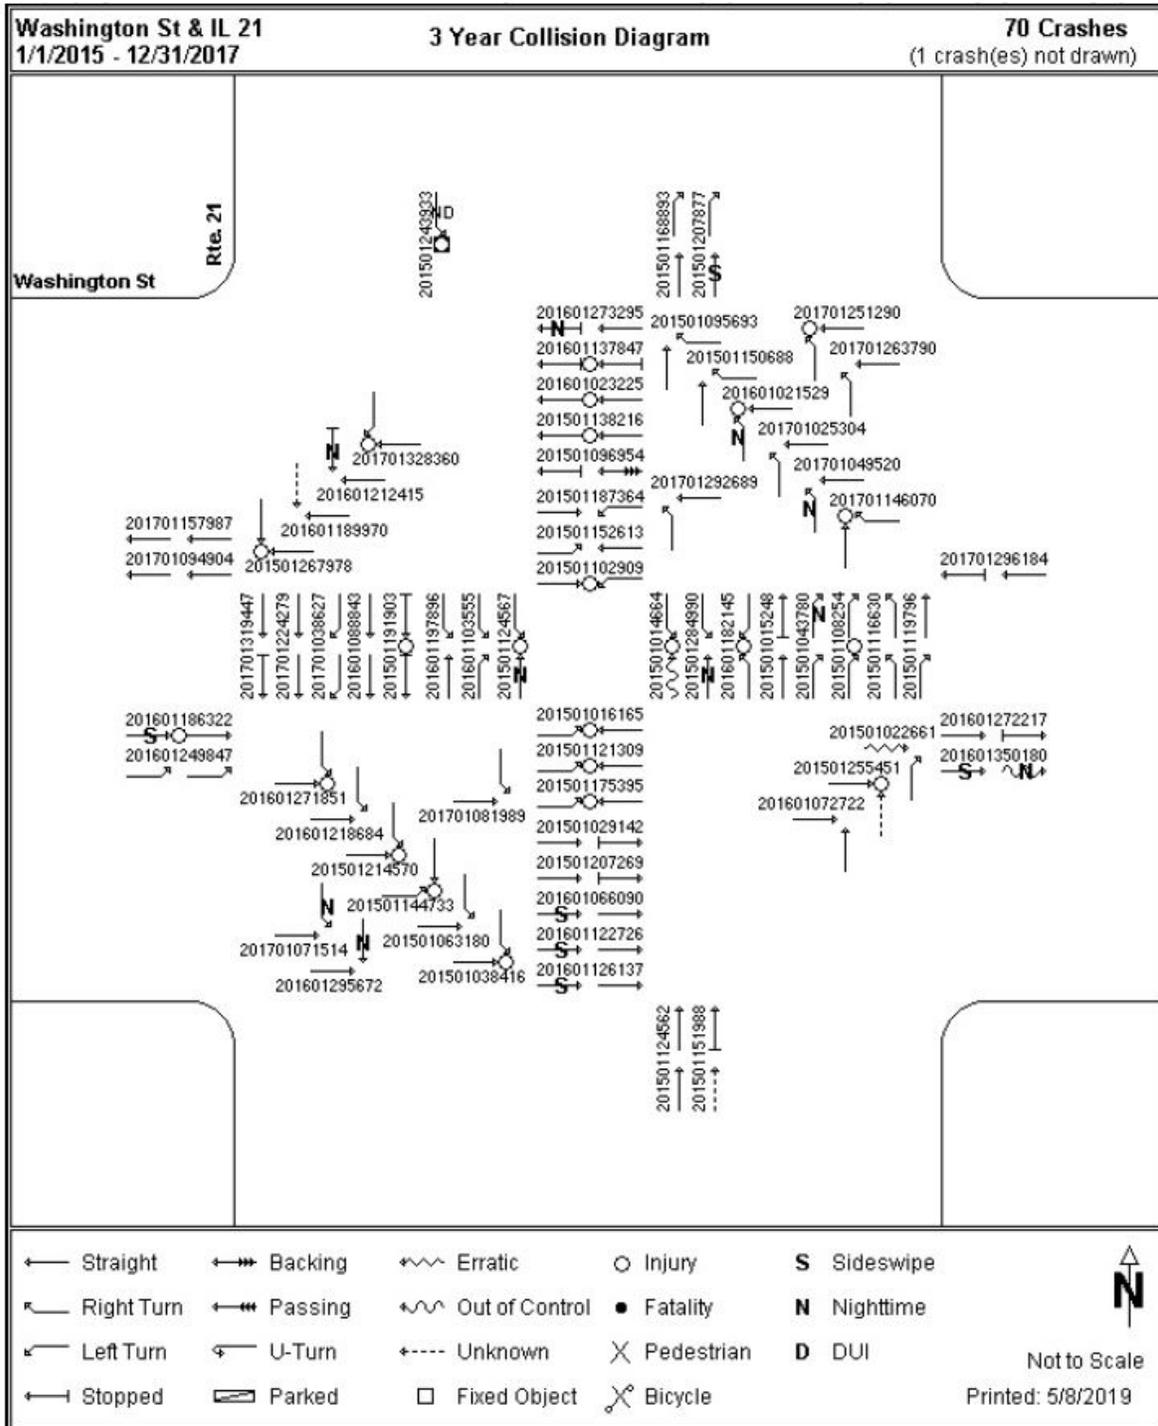
3 Year Collision Diagram (Data Located on Exhibit #1)

1 of 3 Part Diagram

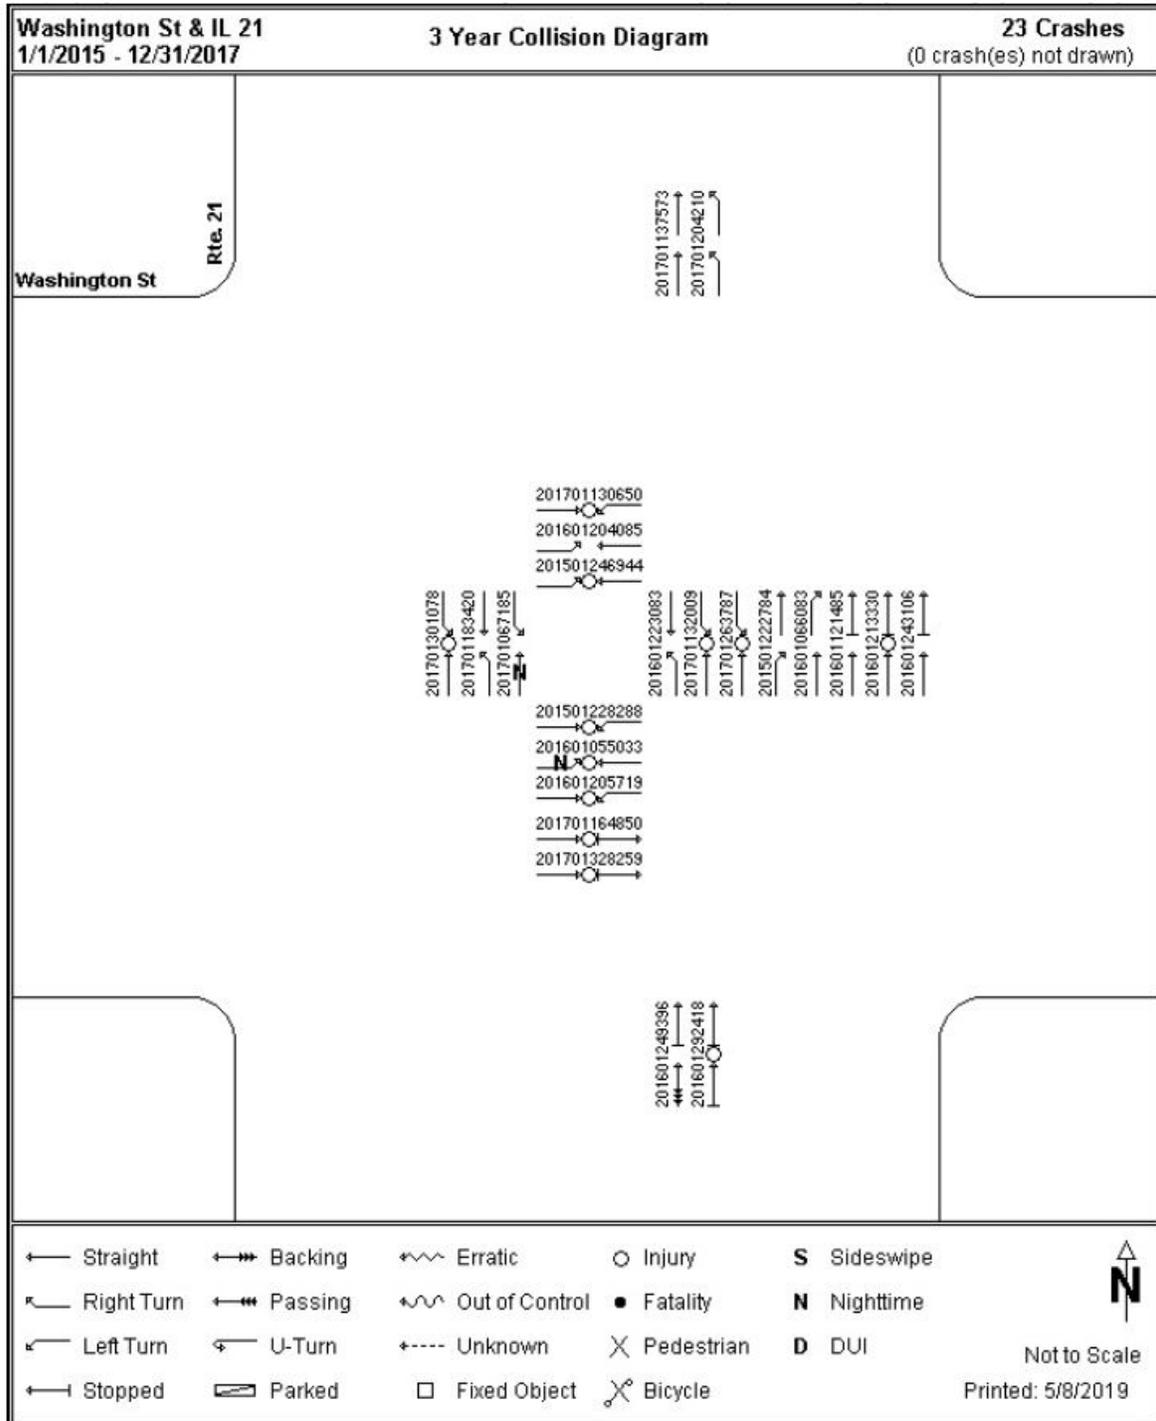
3 Year Collision Diagram (Data Located on Exhibit #1)

2 of 3 Part Diagram

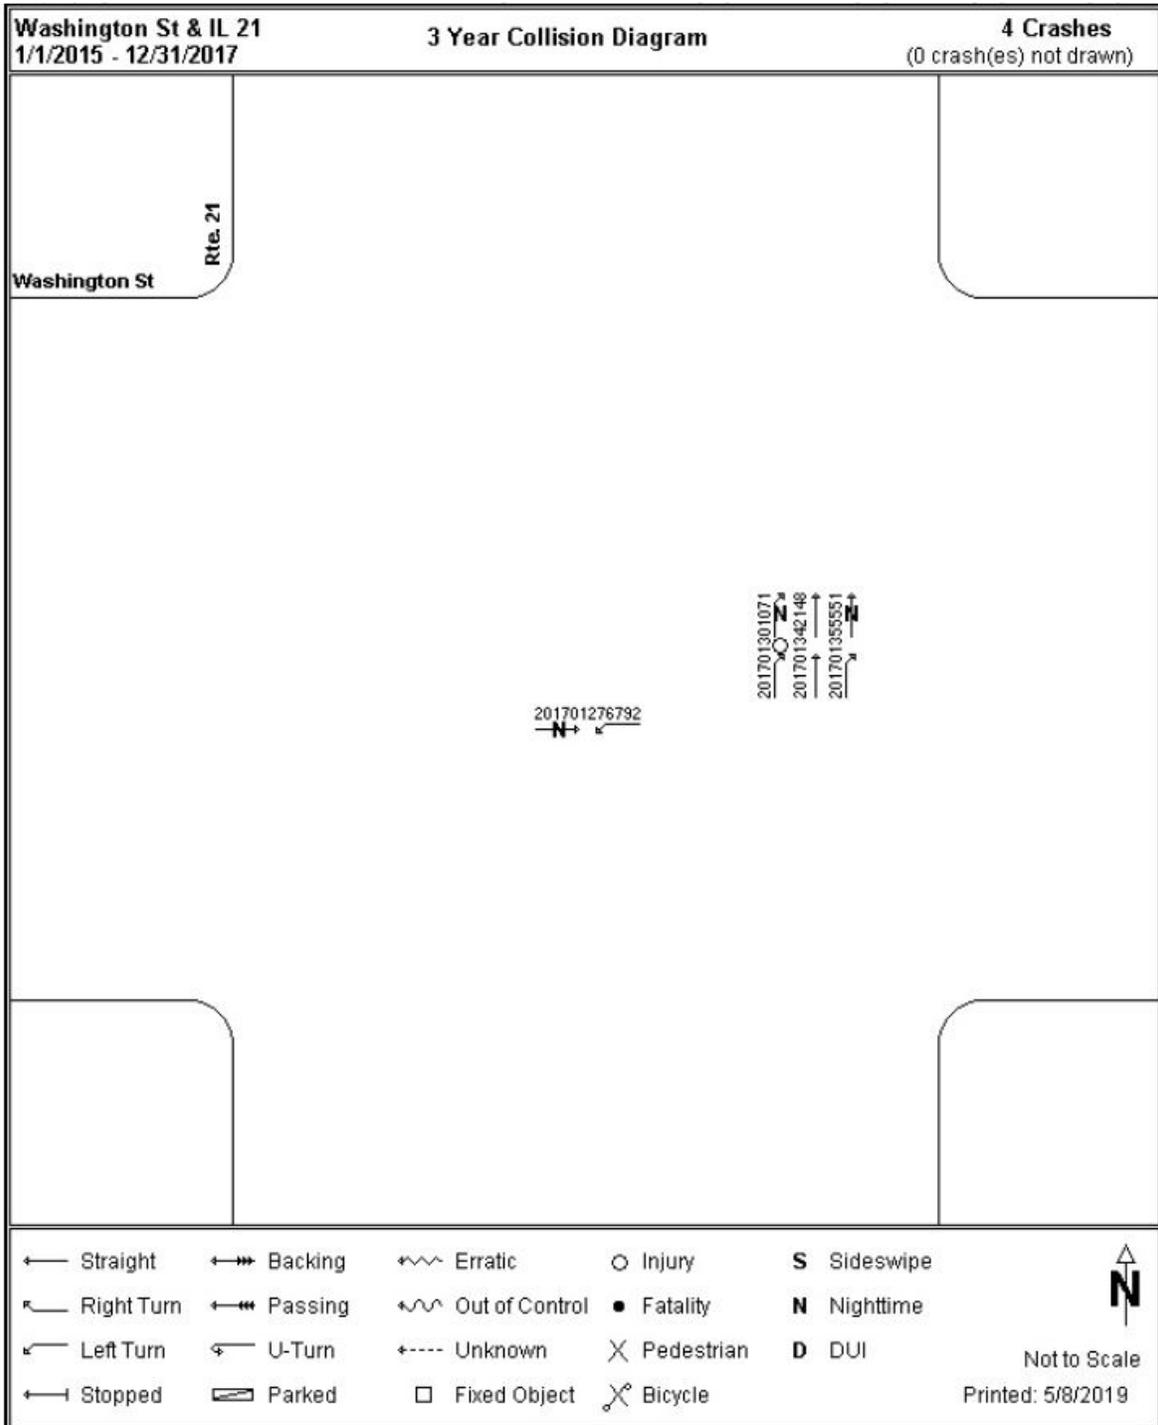
3 Year Collision Diagram (Data Located on Exhibit #1)

3 of 3 Part Diagram

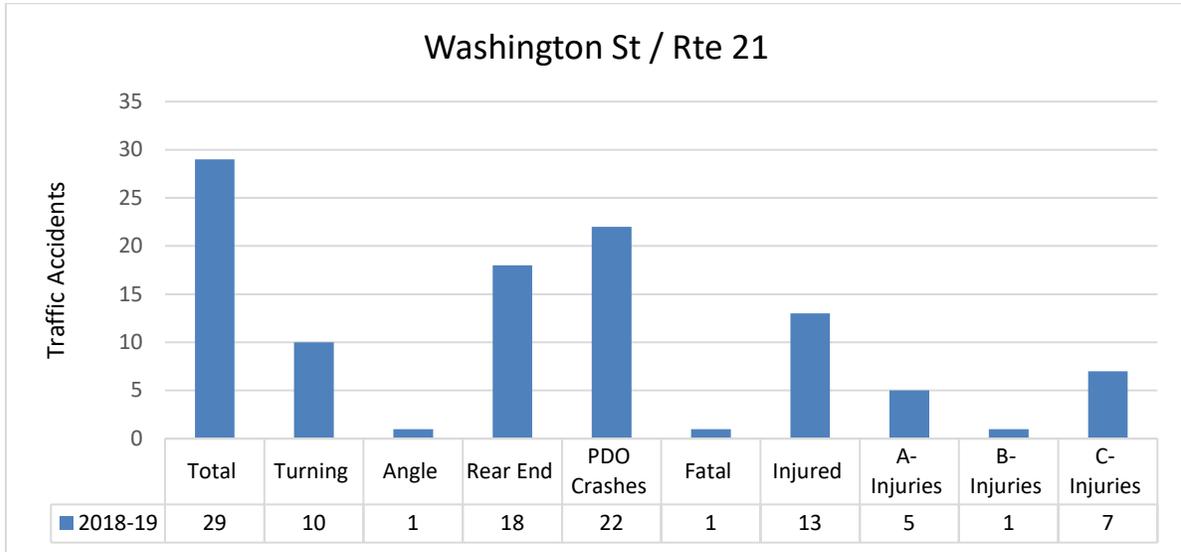
Exhibit #2

**This chart data covers a 12 month period running 05/01/2018 – 04/30/2019. Data for this chart is from the Gurnee Police Department and it has not been reconciled with the Illinois Department of Transportation

There was a noted increase in rear end collisions. Of the 18 rear end collisions, only 2 were attributed to hard braking for a red traffic signal. The remaining 16 rear end collisions were attributed to inattentive drivers.
