# **WASHINGTON STREET / ROUTE 21**

# RED LIGHT PHOTO ENFORCEMENT 3 YEAR FOLLOW-UP REPORT

2019-2021

August 2022

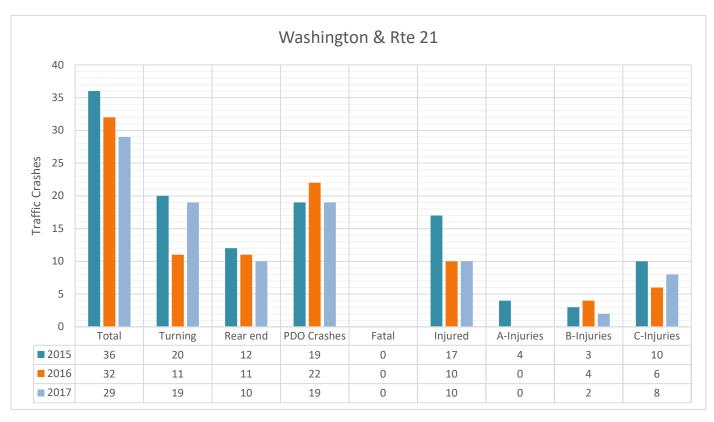
#### Exhibit 1

The crash data specific to the RLR location(s) for the 3-year period (Exhibit #1) prior to and for the period post (Exhibit #2) RLR installation. The crash data shall include yearly collision diagrams of the intersection(s).

Total traffic accidents for this period (50) dropped approximately 48% compared to the previous period total (97).

Overall injuries this period (23) dropped approximately 38% compared to the previous period (37). Type A injury types did increase, but 75% of these are attributed to turn-related crashes and 1 red light violation, several of which involve multiple injuries.

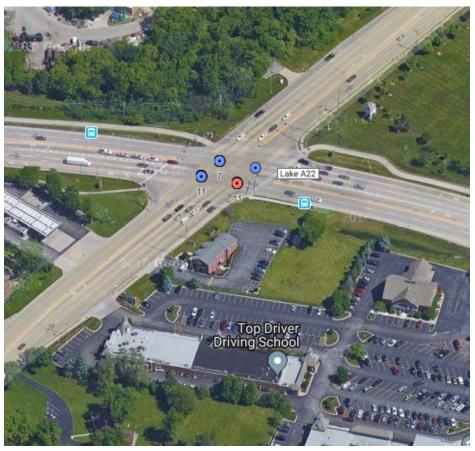
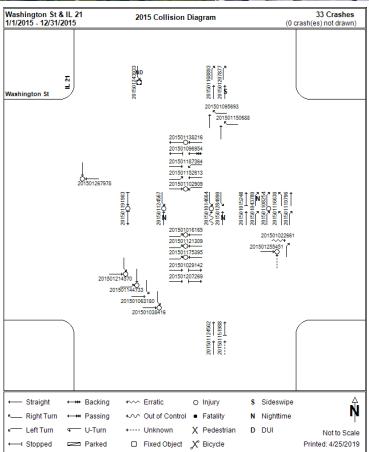
# 2015 Traffic Crash Map & Collision Diagram (Data located on Exhibit #1) Washington Street & Route 21

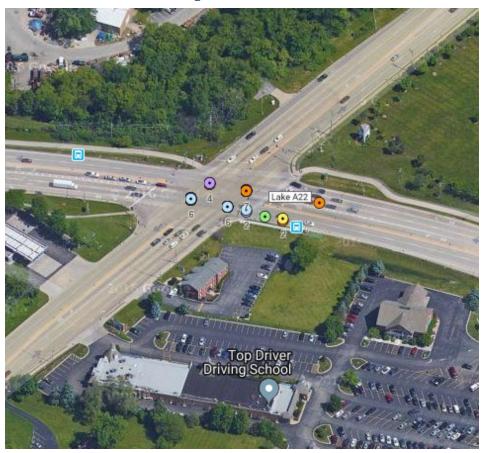
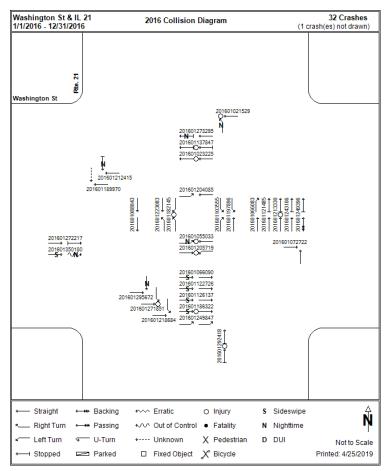
# 2016 Traffic Crash Map & Collision Diagram (Data located on Exhibit #1) Washington Street & Route 21

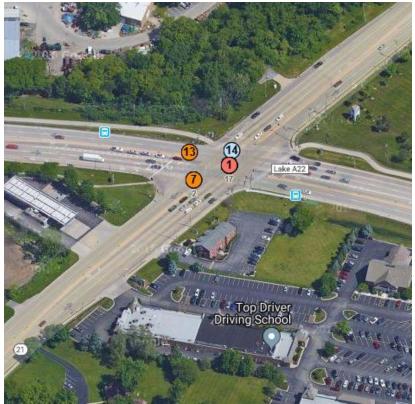
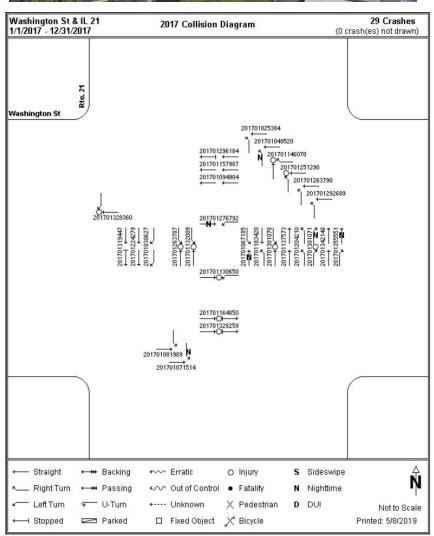
# 2017 Traffic Crash Map & Collision Diagram (Data located on Exhibit #1) Washington Street & Route 21

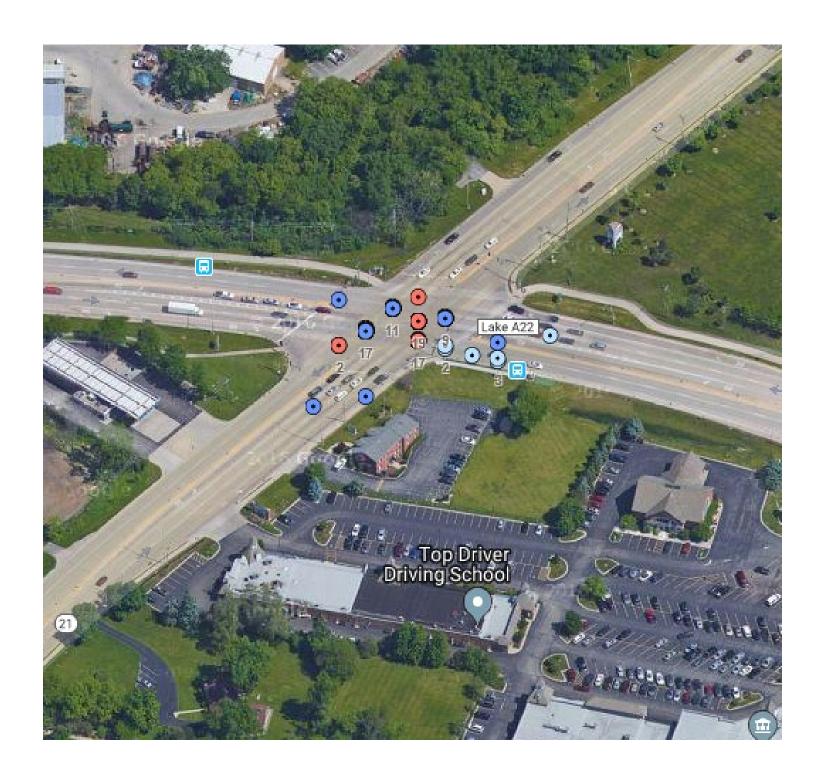
# 2015-2017 Traffic Crash Map (Data located on Exhibit #1) Washington Street & Route 21

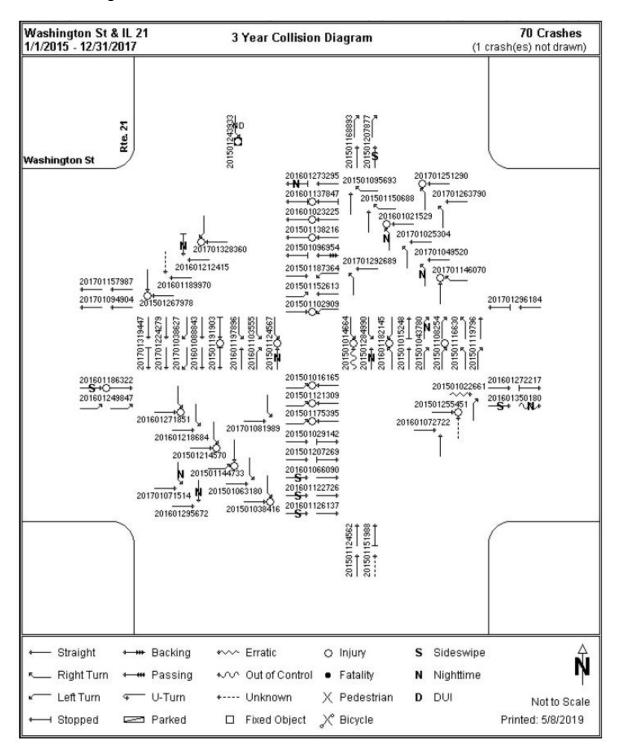
#### 1 of 3 Part Diagram

# 2015-2017 Collision Diagram (Data located on Exhibit #1) Washington Street & Route 21

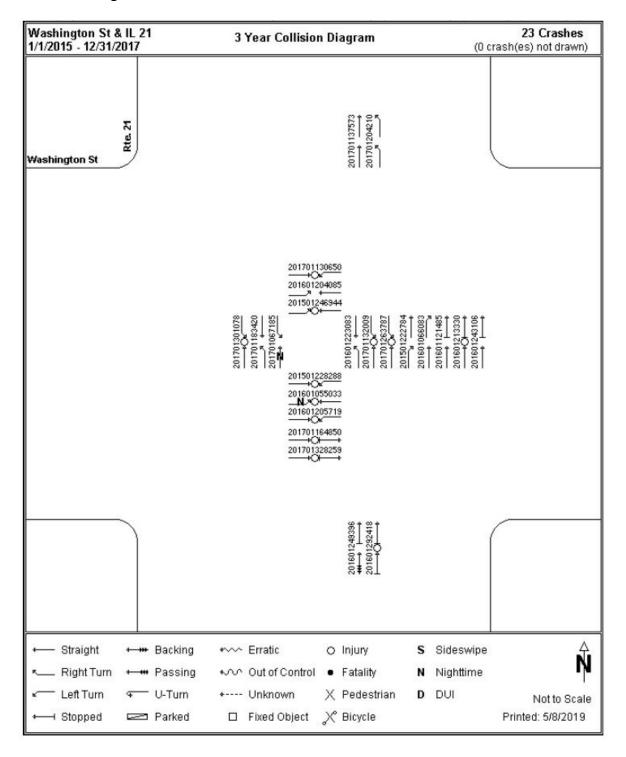
### 2 of 3 Part Diagram

# 2015-2017 Collision Diagram (Data located on Exhibit #1) Washington Street & Route 21

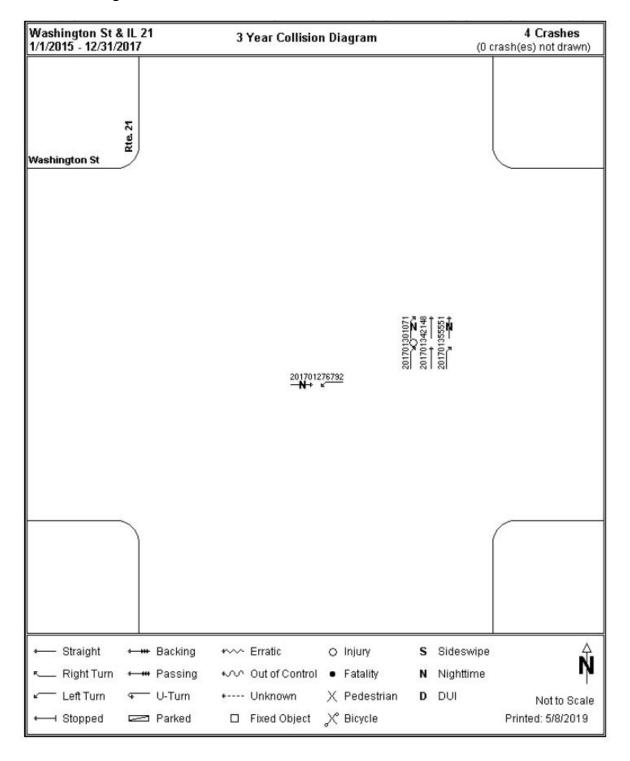
### 3 of 3 Part Diagram

# 2015-2017 Collision Diagram (Data located on Exhibit #1) Washington Street & Route 21

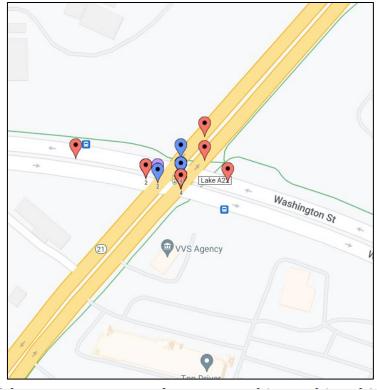
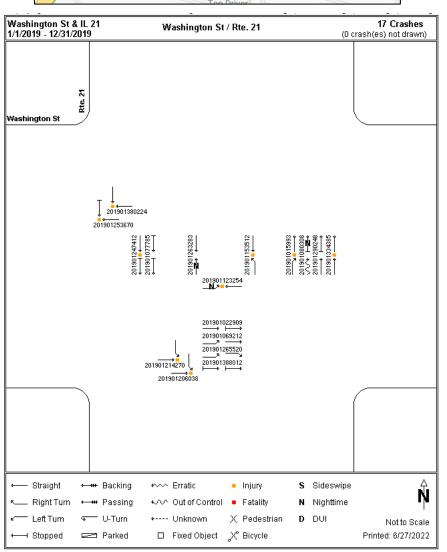
# 2019 Traffic Crash Map & Collision Diagram (Data located on Exhibit #2) Washington St and Route 21

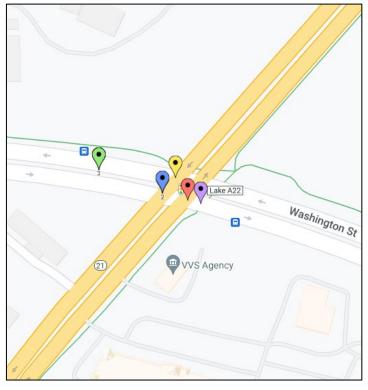
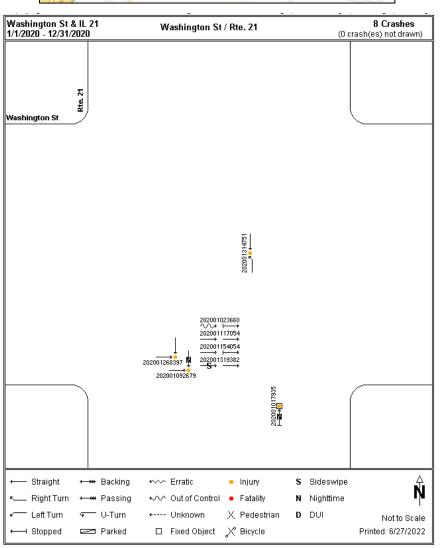
2020 Traffic Crash Map & Collision Diagram (Data located on Exhibit #2) Washington St and Route 21

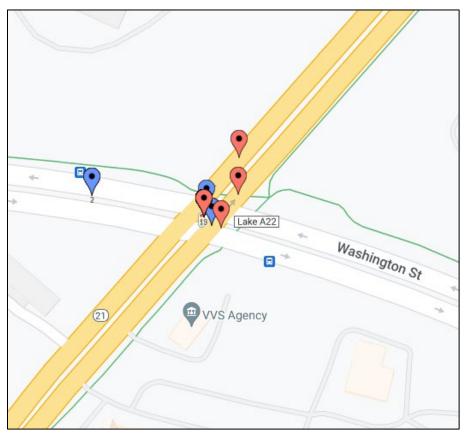
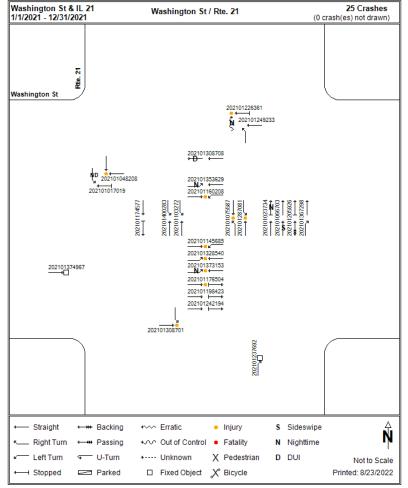
# 2021 Traffic Crash Map & Collision Diagram (Data located on Exhibit #2) Washington St and Route 21

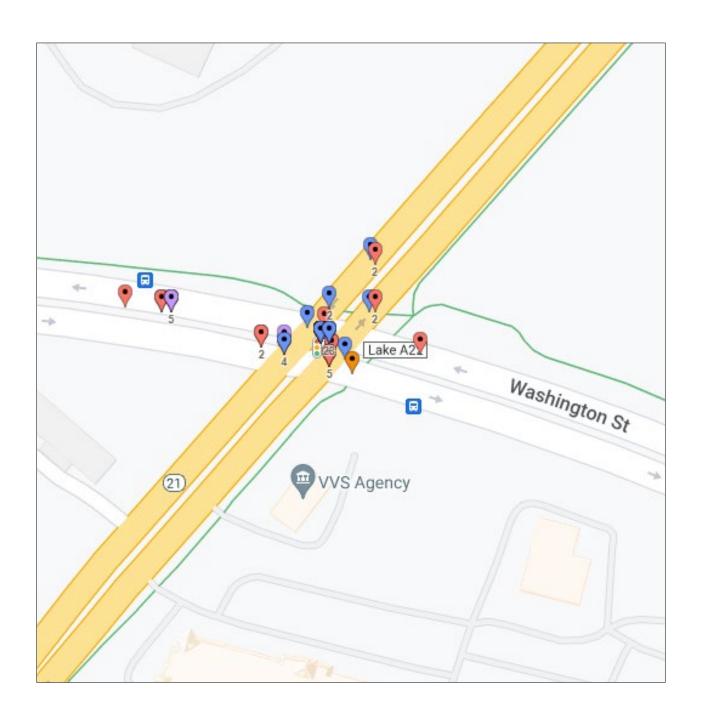
## 2019-2021 Collision Map (Data located on Exhibit #1) Washington Street & Route 21
